Manhole Inspection Summary

Manhole # S07GG2004MH

Location Address: **6300 GREEN MEADOW PKWY**

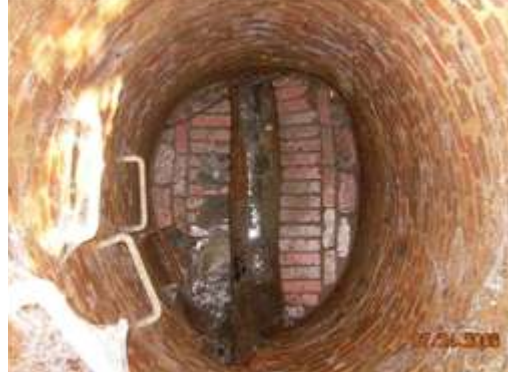
Top View

Corroded steps. Evidence of surcharge - Bench debris. Channel debris.

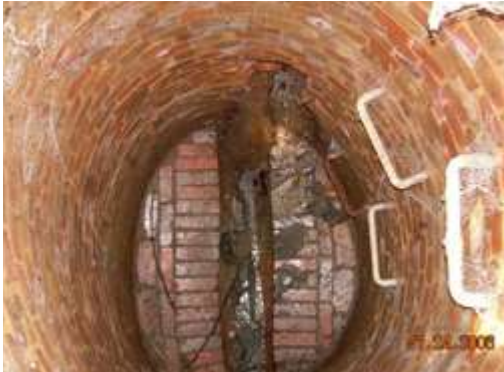
Defect

Frame leaks. Adjustment, Corbel and Barrel infiltration.

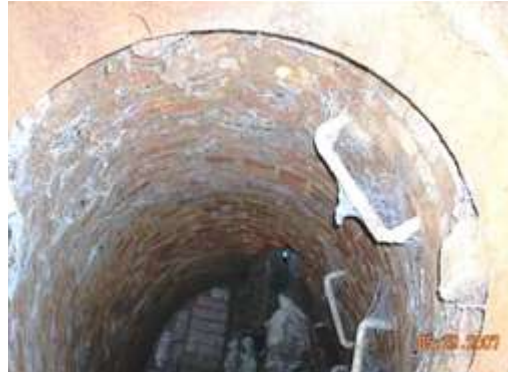
Defect

Frame leaks. Adjustment deterioration, loose brick and infiltration. Corbel and Barrel infiltration - other side.

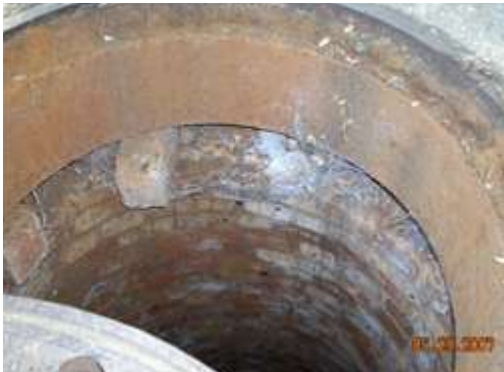
Defect

Frame leaks. Adjustment deterioration, loose brick and infiltration. Corbel infiltration.

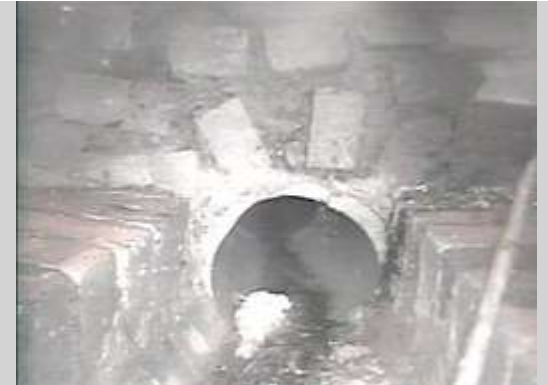
8 in. Circular Gravity Sewer Pipe Out @ 12 O'Clock

Barrel deterioration and infiltration.

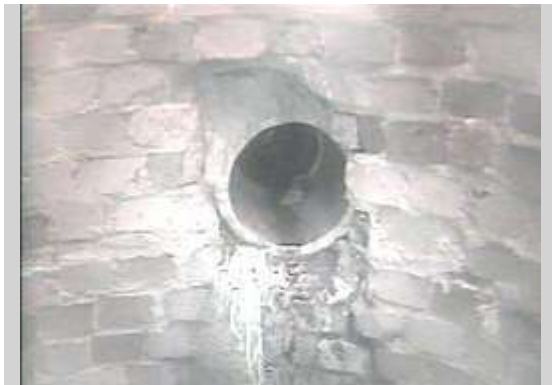
8 in. Circular Gravity Sewer Pipe In @ 6 O'Clock

Comments **There is HEAVY root intrusion coming out of the Barrel wall beneath the I6 pipe in and extends down into the Channel and impeding flow.**

Barrel deterioration, root intrusion and infiltration.
